## **River Bank Erosion; Causes and Impact on human Life: A Case Study of Samserganj Block, Murshidabad, West Bengal**

The Ganga is India's most important and iconic river. The lifeline of India is the Ganges River. It flows between India and Bangladesh. The Ganga River originates from the Gangotri Glacier in Uttarkashi District, Uttarakhand. After entering West Bengal, the Ganga divides into two parts near Mithipur in Murshidabad district known as Bhagirathi and Hooghly in West Bengal and Padda and Meghna in Bangladesh. Murshidabad district lies on the left bank of river Ganges which is a flood plain region of West Bengal. River bank erosion is the most effective environmental disaster in Murshidabad district. My study area is Samserganj block which is located in the northern part of Murshidabad district. River bank erosion is a major problem

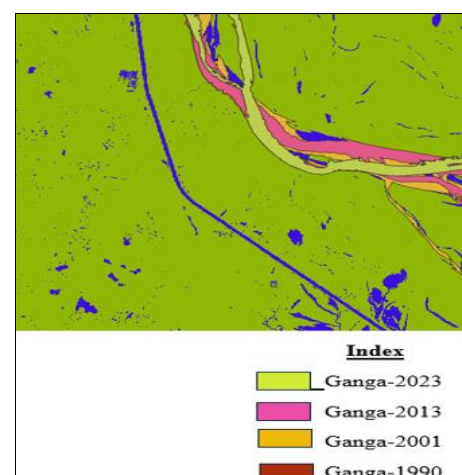
Due to the construction of the Farakka barrage (between 1962 and 1971) across the Ganga River, the whole river course has been altered, and gradual meander formation has started between the Rajmahal hills and Farakka (Mukherjee, 2011). The above fig of Samsanganj shows that the river is constantly shifting to the left side. The river is coming directly and hitting the left side in the areas of Dhusaripara, Shibpur, Kamalpur, Dhangora, so the erosion is more in these areas. Basically, channel shifting is the main cause of river erosion in this region.

This section will present the shifting courses of the river Ganga from the year 1990 to 2023 in the study area. The changing course of the Ganga River has been continuously reshaping the boundary of Murshidabad District. Rivers transfer millions of tons of sediment with their flow. These sediments accumulate in the plains every year, creating many problems such as decreased river width and depth due to siltation. When the amount of discharge increases, bank erosion is initiated, causing floods and river-bank erosion (Thakur, 2011).

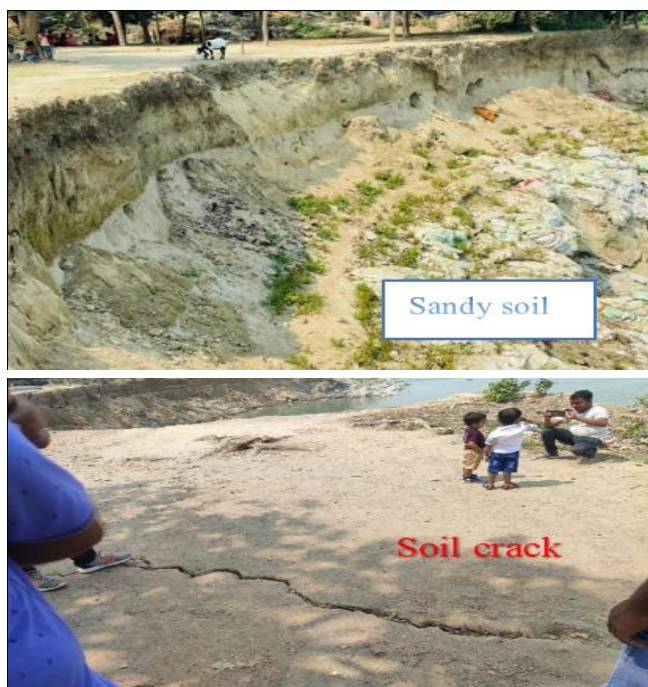
The type of soil plays a crucial role in River Bank erosion. The type of soil, its texture, structure, and composition can all affect erosion rates. The Murshidabad District belongs into the zone of alluvial soil. The characteristics of the soil also have great impact on the extent of erosion. The banks adjacent to Samsanganj block have been formed by alternate layers of silt, clay and sand. Different soil types have different levels of permeability and resistance to erosion. Sandy soils are more prone to erosion than clay soils. The river bank here is composed of sandy soil, which is highly permeable and prone to erosion. Soil that is too dry or too wet can be more prone to erosion. When soil is dry, it becomes more compacted and less able to hold together. When soil is too wet, it becomes more saturated and less able to support vegetation. One example of the impact of soil on river bank erosion can be seen in the Samsanganj area of West Bengal. The river bank here is composed of sandy soil, which is highly permeable and prone to erosion. In addition, the soil structure is poor, with little organic matter to hold it together. This makes the river bank vulnerable to erosion, especially during periods of heavy rainfall or flooding.

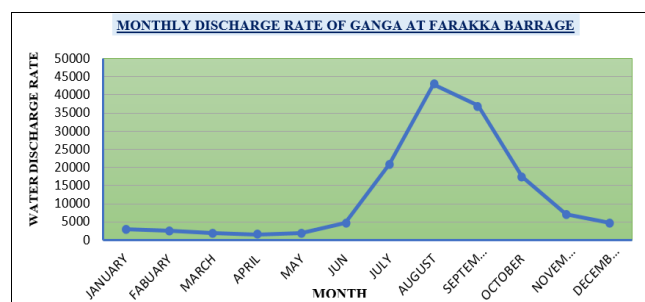
Monthly water discharge rate of Ganga at Farakka barrage

Data source: World runoff data

Before the construction of the Farakka barrage, the Ganges River used to carry a large amount of sediment downstream, which helped to maintain the stability of the river banks. However, after the construction of the barrage, the flow of water in the Ganges River has been significantly reduced, which has resulted in a decrease in sediment transport downstream. As a result, river bank erosion has increased significantly in my study area.

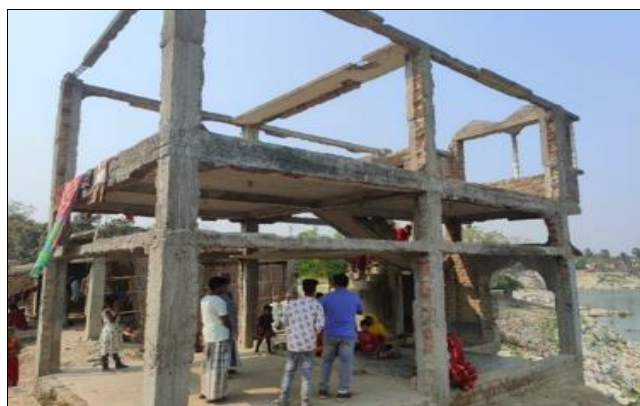
**The damage to infrastructure and homes:**

Caused by river bank erosion in Samsanganj can have significant social, economic, and environmental impacts on local communities. When river banks erode, infrastructure such as roads, bridges, buildings, and utilities located near the river are at risk of being damaged or destroyed. River bank erosion can damage roads, bridges, and transportation networks, making it difficult for residents to access essential services, markets, and emergency assistance. Disrupted transportation routes can isolate communities and hinder economic activities, leading to increased transportation costs and delays. Erosion-induced land loss can result in the destruction of homes, buildings, and property located near the river bank. Residents may be forced to evacuate their homes due to safety concerns, leading to displacement and loss of shelter. The loss of homes can have emotional, financial, and social impacts on affected families.

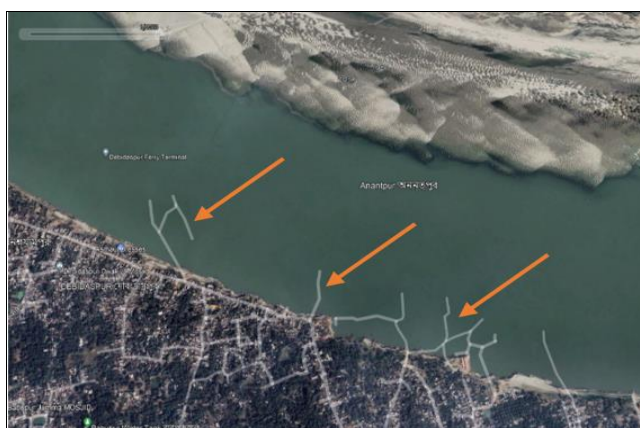
Source: Google earth

The Basic problem of the affected region of riverbank is transport. It is frequently found that after a flood the road way communication become so much hampered that the area become paused due to lack of proper commination system. Many roads have been washed away which can still be seen on google earth but do not exist in reality. Shown in the picture below. Erosion can also damage infrastructure such as bridges, roads, and other structures built near the river.
